# FEMA

## Multiple Mitigation Measures Give Darlington An Elevating Experience

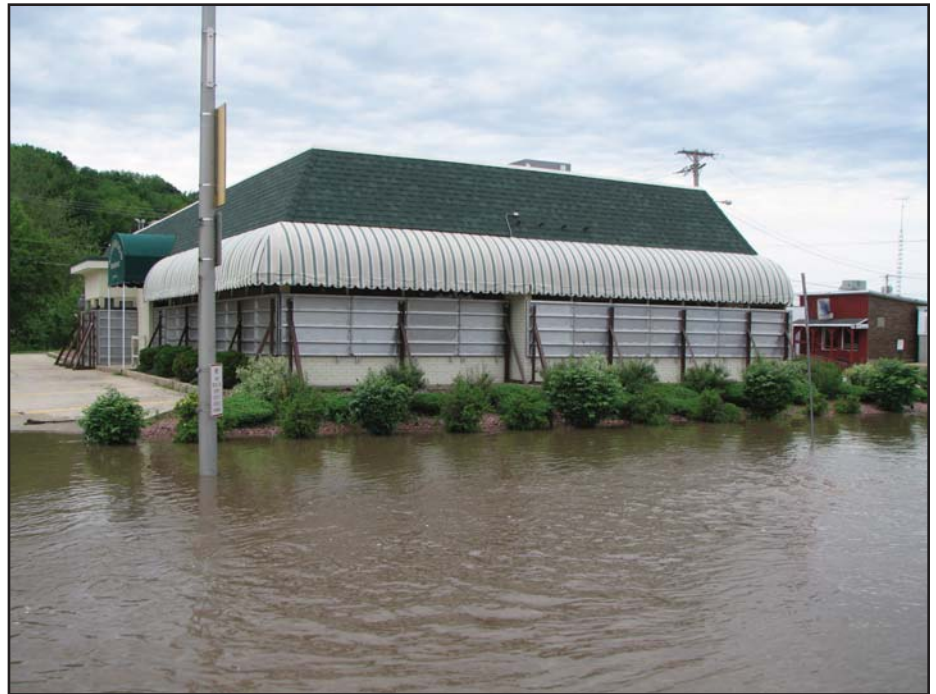
A Darlington business with flood shields installed shown during a 1998 flood.

The flood shields were designed to prevent flood waters from entering the downtown businesses. Made of a corrosion-proof aluminum, the shields would be clamped to rigid steel stanchions. The stanchions were to be cast into the top concrete entry portals, leading into the proposed raised levels of Main Street’s businesses. The shields were to include rubber seals on three sides and were to be held in place by hand-cranked levers that pulled them tightly against the stanchions at the top of each entry way. Next, a major piece of the project would come together with the addition of hardened concrete vestibules. These

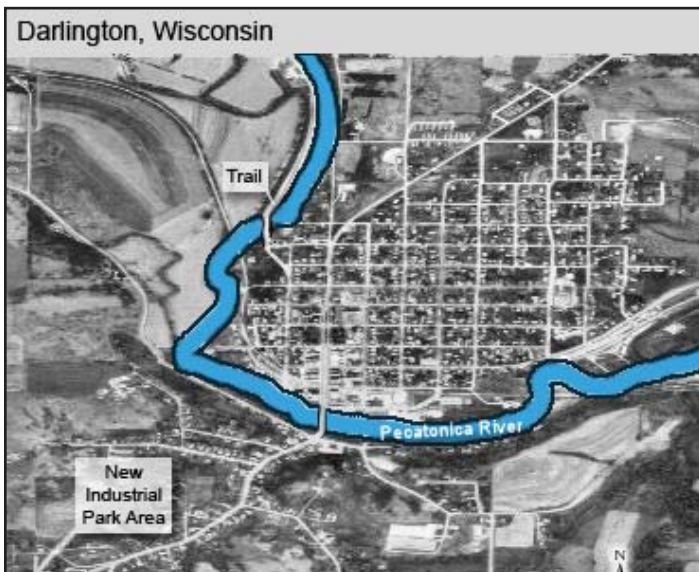
Aerial view of Darlington showing flood-prone area between bridge over east-flowing portion of Pecatonica River and horseshoe bend.  
Photo courtesy of USGS

A sturdy concrete and steel bridge crossing the river connects Darlington's business district to the south side of town. It is in this low-lying area on the north bank of the river between the bridge and the horseshoe bend that waters from the Pecatonica most frequently invade downtown. Most of the buildings here date back to the mid-1800s and are of considerable historic importance. Across the bridge, the street continues up hill, away from the river, and passes through a residential area on its way to a rapidly-developing industrial park.

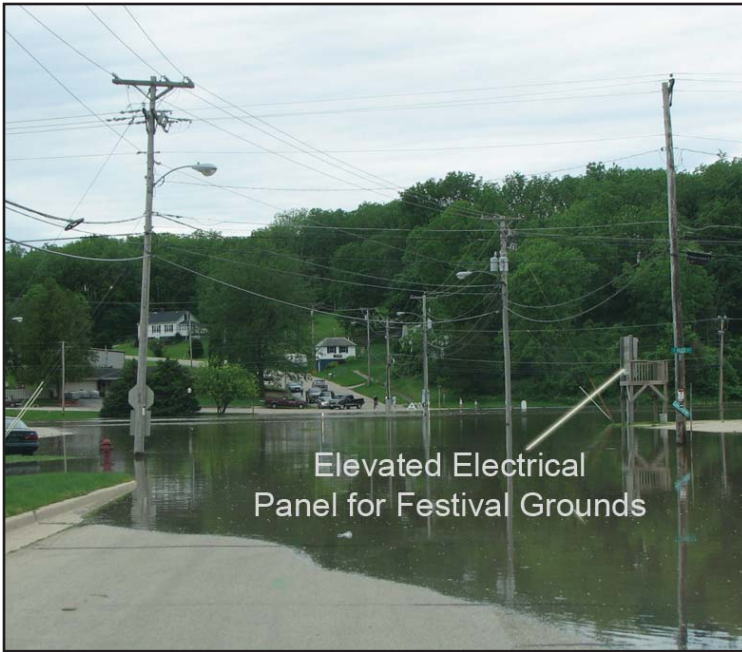
Elevated Electrical Panel for Festival Grounds

Darlington's flooded Festival Grounds: Where buildings used to stand soaking in damaging waters, there is now open space.

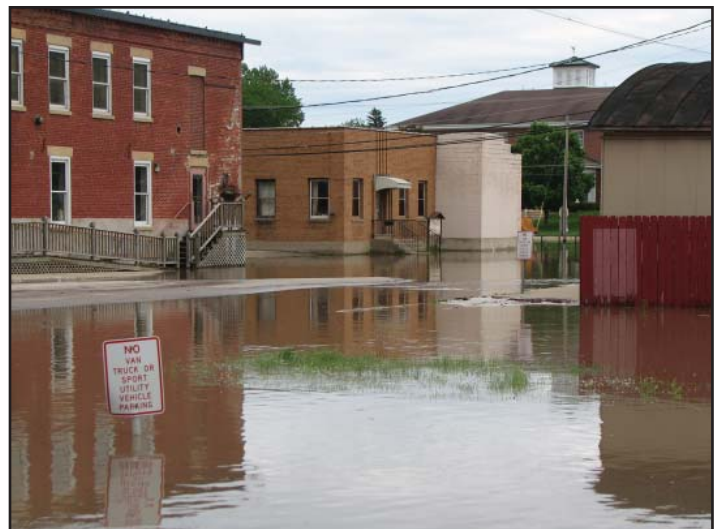
Buildings on a Darlington side street surrounded by flood waters in 1998.

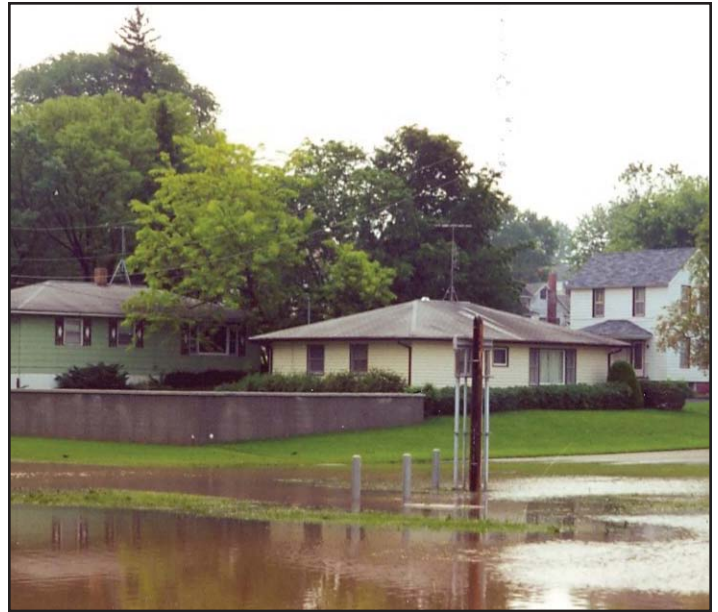
*Partial barrier protects yellow house (center right). Barrier keeps high water off the property and prevents excessive erosion. Design feature prevents barrier collapse by permitting flood water to enter yard from highest end of barrier (near corner of house). Should flood waters reach this height, they would begin to fill the yard behind the wall, equalizing pressure. Removable plugs at bottom of wall permit water to drain after flood has subsided. Green house on left is elevated to protect it from floodwaters.  
Photo: Phil Risseeuw, Darlington*

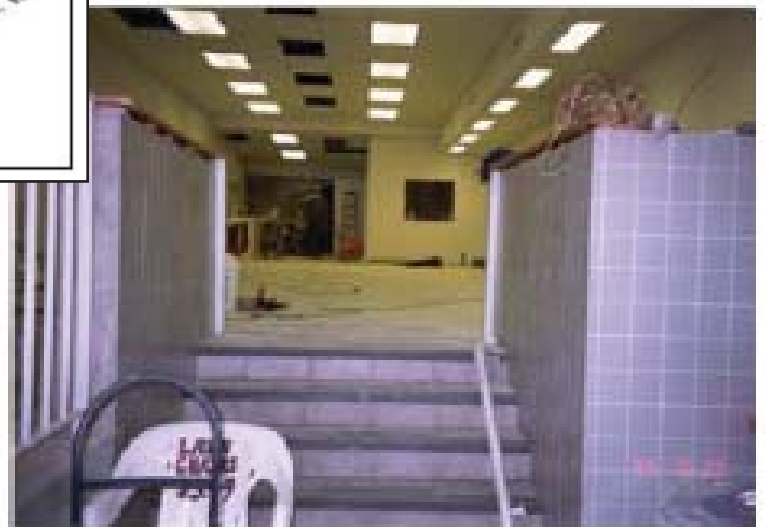
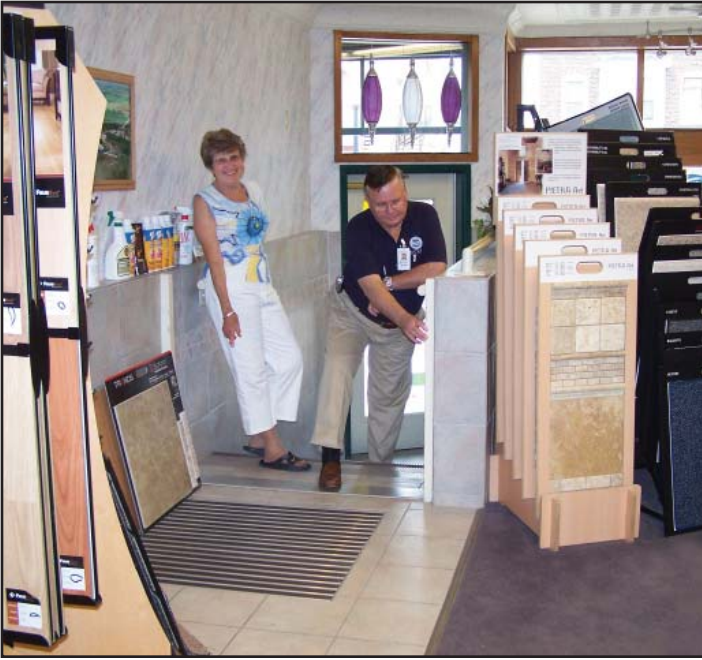
*Former Darlington Mayor Bev Anderson and FEMA Mitigation Specialist Chuck Black inspect stanchions and drain cover at top of steps leading into a Main Street business. It is at this point that flood shields are attached when flooding is imminent.*

*Black and Anderson start up ramp behind Main Street stores. Ramp provides access to businesses during high water when flood shields are in place in front of stores. Walls surrounding ramps provide additional flood protection. Utilities (electrical and gas meters and connections as well as air conditioners) are raised high above potential flood elevations.*

Meeting the ADA requirements called for constructing a shared, concrete, handicap-access ramp constructed in the rear of the downtown buildings. The ramp not only would serve several buildings, it also would act as a flood barrier.

Among the Mitigation Plan’s projects were those that accomplished the following. Darlington’s waste water treatment facility was relocated away from the flood zone. All major utilities such as gas and electric in the flood zone were raised as much as eight feet off the ground. Anything that had previously been covered by floods would now be high and dry. As each project to resuscitate the ailing city was completed, the excitement and enthusiasm of Darlingtonians grew.

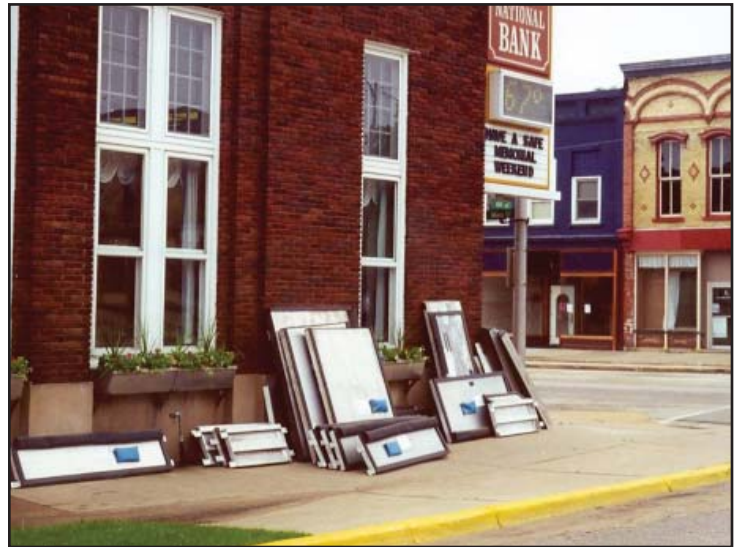
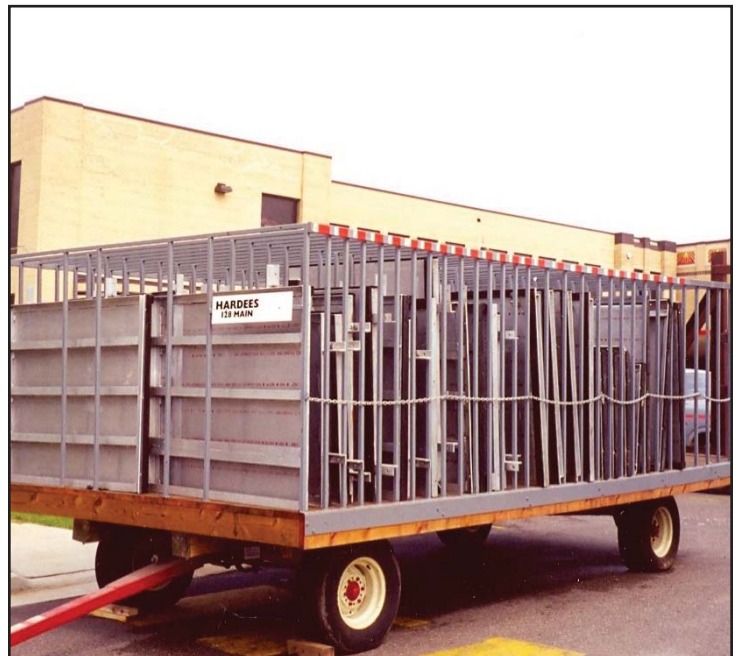
*Shields for bank lean against building awaiting deployment to their specific location for flood-proofing doorways and windows.*

*Specially built wagon holds shields while in storage. Pick-up truck tows wagon short distance to buildings for which shields were custom made.*

Each of the 150 shields were numbered and lettered for the specific buildings on which they would be installed. The River Wood Restaurant alone, located nearest to the river, required 30 shields to seal all doors and windows on four sides. Next, three retrofitted, modern, metal hay wagons were acquired to hold the shields when not in use. The wagons, each holding 50 shields, were parked in a specially constructed three-door garage at the bottom of Main Street.

When flooding is imminent, an appointed flood shield distributor driving a pick-up truck with a ball hitch simply backs-up to each of the three garage doors, hooks up the wagons, then drives around the corner to pre-planned locations where individual business owners slide their shields off the wagons and install them on their buildings.

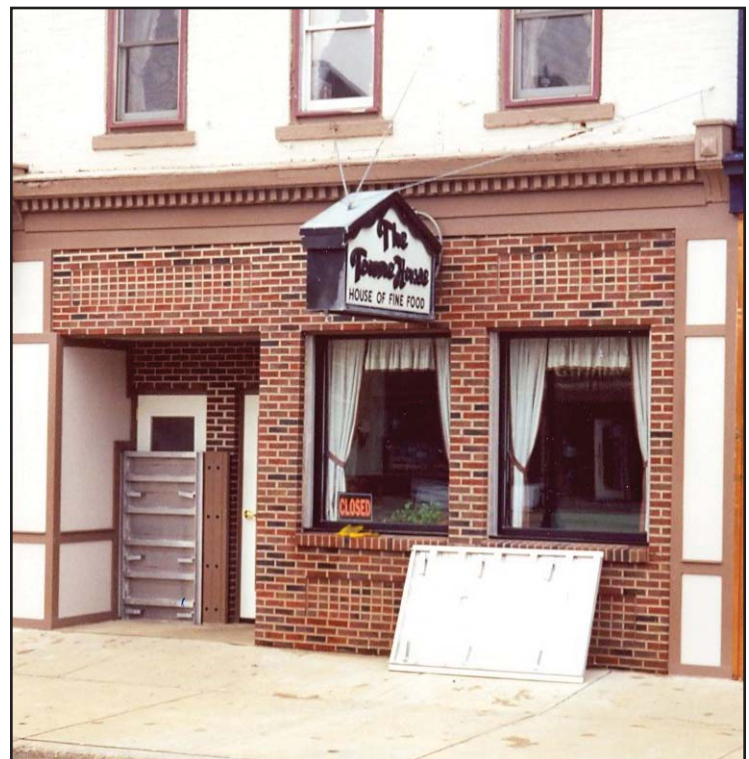
*This Main Street restaurant was mitigated with hardened concrete vestibule and flood shields inside. The entrance to the apartment above the business is shielded from the outside.*

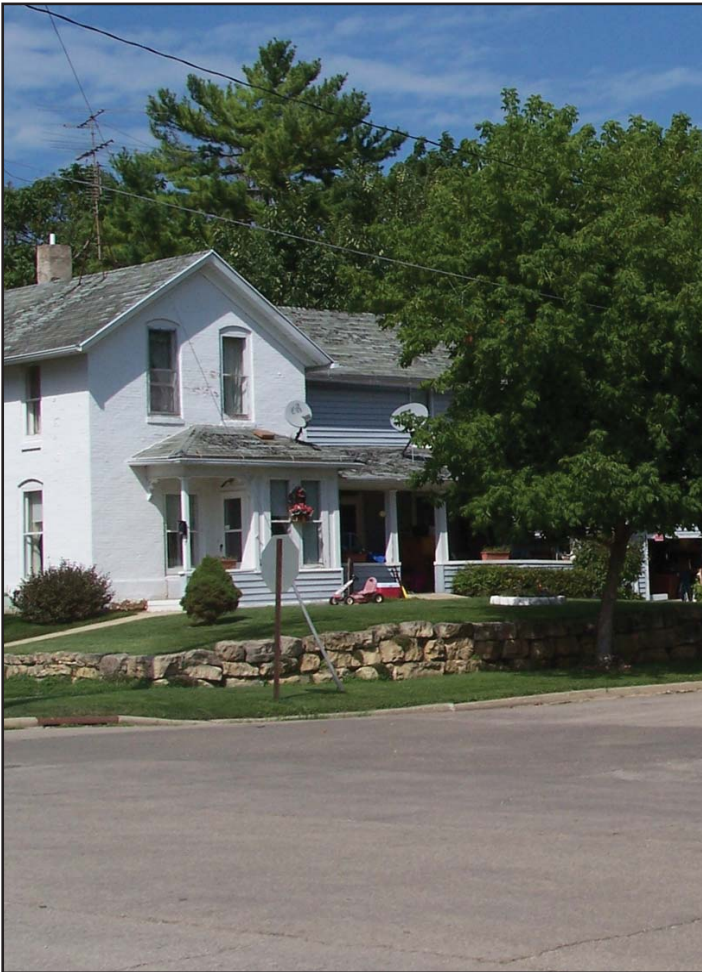
*House at the end of a block of several elevated homes across street from Darlington's new ball fields. Lots and homes all are raised above the Base Flood Elevation for this neighborhood and were not flooded during the June 2008 flood.*

The downtown district wasn't Darlington's only concern though. Adjacent neighborhoods and businesses also were being swamped by flood waters. As a part of the town's total mitigation plan there were several items to be taken care of. They consisted of elevating many affected homes and their utilities above the base flood elevation (BFE). Participating homes in the flood zone elevated all utilities and furnaces. Those with basements had them filled-in with crushed rock. Some homes had concrete walls erected on the exposed sides prone to flooding. Approximately 55 homes were involved.

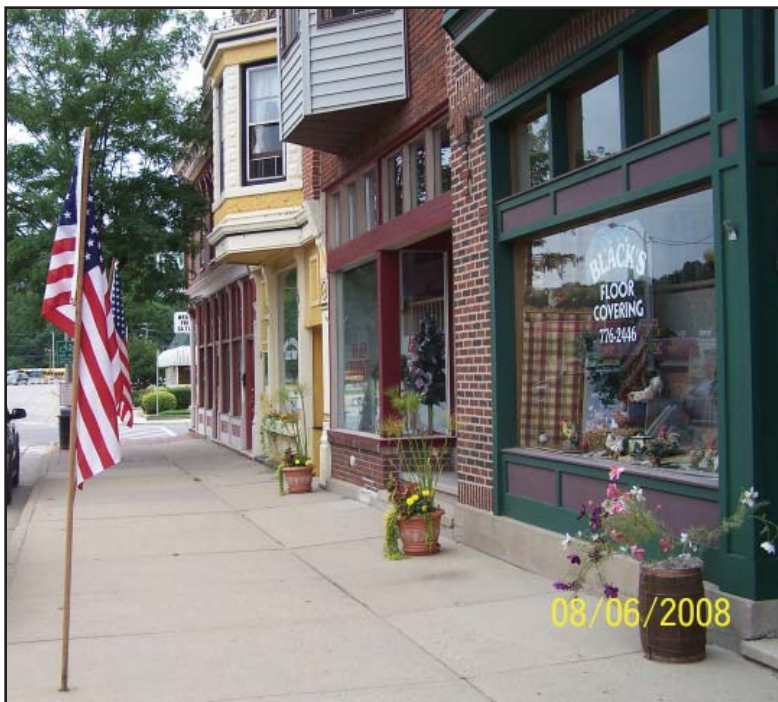
*Historic buildings that grace Darlington's Main Street are protected from flood damage and their historical character is preserved.  
Photo: Barbara Ellis, FEMA*

During the two most recent Wisconsin floods, those of 2007 and 2008, the city of Darlington was “armored and ready” for whatever Mother Nature decided to throw at it. The flood shields stopped virtually all flood water from entering businesses, elevations of buildings and utilities prevented further damage and the residents and business owners were afforded peace of mind in knowing they were protected this time.
